# PSEG Long Island MyHEAT Users Guide

May 5, 2025

# MyHEAT's Home Energy Efficiency: A Complete Guide

# Exhibit A: 1959 Bungalow with Attached Garage

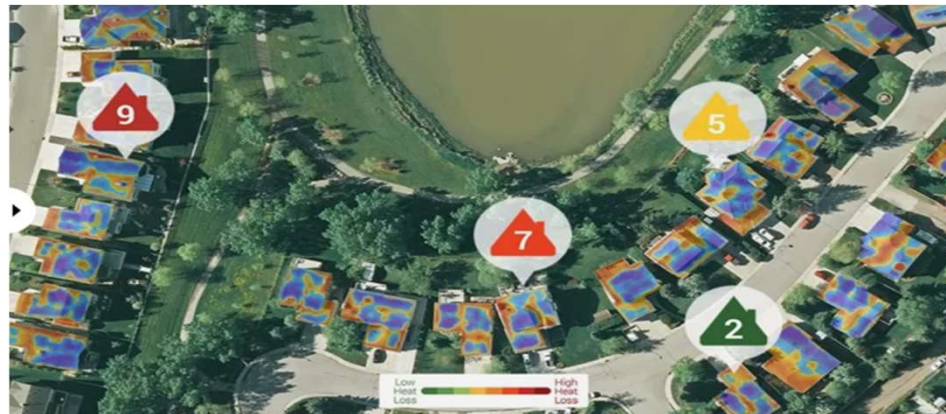
- The MyHEAT team developed an aerial infrared Heat Loss Map of residential, municipal, commercial, and industrial buildings throughout Long Island and the Rockaways, New York.
- PSEG Long Island has reviewed this Heat Loss Map and found the imaging is useful for Energy Assessments and other analysis.
- PSEG Long Island has incorporated this Heat Loss Map into the PSEG Long Island Energy Efficiency Program to provide partners and customers with this detailed heat loss tool to increase heat loss awareness and display a detailed Home Energy Analysis.

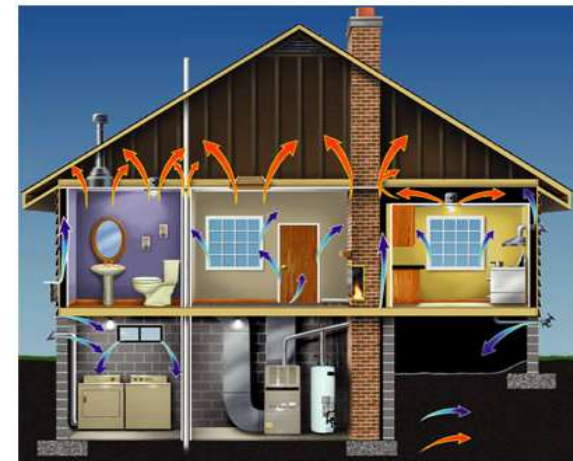
Heat Loss Examples

- Structural Flaws
- Inadequate insulation
- Heat transfer mechanisms
- Windows and doors
- Ventilation systems
- Behavioral factors
